ITEM CODE: 03300060

Report No. 05-1002-202006-52

Parts Inspection Report						
Sample delivery		Sample supplier	ATECPOOL			
Document coding	Parts Test Scheme -20200520-0001	Sample manufacturer	ATECPOOL			
	Material Name: Titanium Tube Heat Exchanger Material Code :32012-120056 Specification :Φ9.52×7 m Φ110 titanium threaded tube Quantity of samples :2 pcs Source: Procurement Centre Design specificity: Design scope of application (including dry and wet balls, indoor/outdoor):					
Inspection Category	□⊠□ Individual testing	New Mate	Material Test Periodic Test			
Information confirmation	⊠	☐ Specifications RoHS of Certification Information⊠				
Inspection items	Appearance, Structure Size, Fluorine Cleanliness, Waterway Leak, Fluorine Leak, Pressure Change, Pressure Test, Salt Spray Test, RoHS					
Inspection cycle	12 June 2020-22 June 2020					
l Conclusion	☑ □ Eligibility This test a total of 9 items 9 items qualif	fied 0 items unqual	ified.

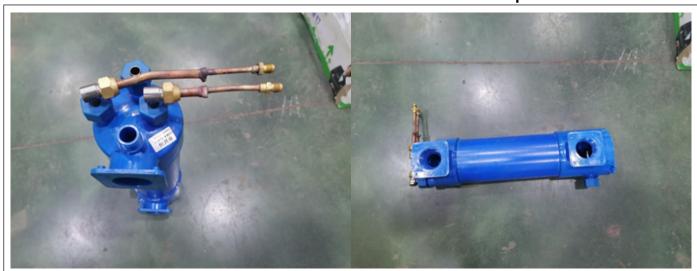
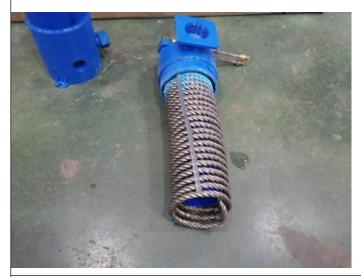
Figure 1: Appearance

Serial numbe r	Testing projects	Standard requirements	Test results	Single decision	Remarks
1	Appearance	1) complete product surface should be clean, do not allow oil stains, stains, etc. 2) heat exchanger inlet and outlet pipe should be round, mouth no burr and oxidation phenomenon, the surface should be smooth, no dirt. 3) the weld of the heat exchanger is even and full, without defects such as porosity, crack and flow hanging. 4) Heat Exchanger External Pipe Splicing surface without cracks, slag, delamination and other defects	Sample intact	Qualified	See Figure 1
2	Structural dimensions	Compliance with technical drawings and documentation requirements	Same size	Qualified	
3	Fluorine Cleanliness	1) put the filter paper in a petri dish and dry in °C 110 drying oven for 1 h; 2) the extraction of quantitative "strong oil remover" into small containers, into the oil meter determination, zero; 3) appropriate amount of zero after the extraction liquid poured into the beaker, and then the "strong oil remover" from the heat exchanger refrigerant side of the interface end injection; 4) the special fixture is installed, the "strong oil remover" in the heat exchanger is recovered into the beaker with 20 min of clean and dry nitrogen blowing, the recovery amount should be more than 60%, and then the recovery liquid is put into the filter bottle and collected; 5) extraction and quantitative filtration of "strong oil remover" into a small container, put into the oil meter for concentration determination; 6) record the concentration, calculate the residual oil component of heat exchanger = determine the concentration value × dissolution dose; 7) according to 120 mg/m2 below the eligibility criteria to determine whether the heat exchanger is qualified; After the 8) test, wash the tested utensils with extraction liquid and put them in an automatic drying box.	About 19.12 mg/m² cleanliness	Qualified	Figure 2

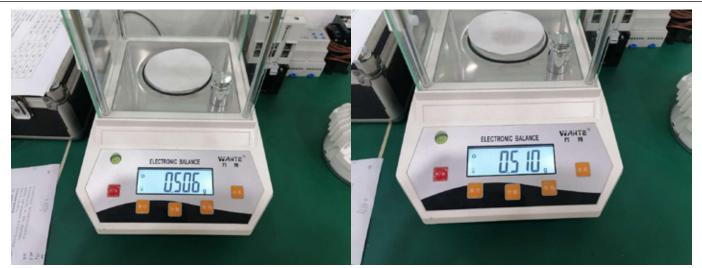
Figure 2: Fluorine cleanliness

The impurity content of titanium tube is 4 mg, the inner surface area is about 0.2092 m², the cleanliness is about 19.12 mg/m².. The impurity content of titanium tube is calculated

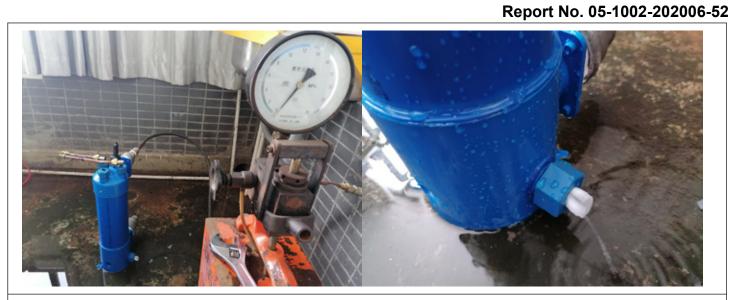
Figure 3: Waterway leak detection

4	Waterway leak	Add 0.5 MPa water pressure to keep pressure for	Pressure to 0.8	Qualified	Figure 3

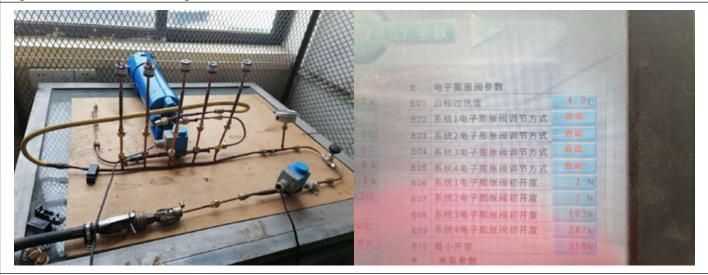
Figure 4: Pressure alternating

Report No. 05-1002-202006-52								
	detection	15 minutes, the whole pipeline must not have	MPa,						
		seepage and deformation phenomenon.	temperature-se						
			nsitive blind						
			tube leak						
5		There are two methods: choose either of them, prefer halogen test: 1. halogen test: fluorine system filled with at least 50 g of snow species, then add 3.5 mpa of nitrogen, mixed with halogen detector test The annual leak rate of the leak detector < g/ years. 2. fluorine system is filled with 5.0 mpa nitrogen, the product is placed in water, welding joint	No leakage	Qualified					
		inspection 2 min.							
6	alternating	Water system: the frequency is at least 10 times / min, the pressure is between 0 Mpa——2.5 Mpa alternately to carry on 6000 times to the fluorine road system impact, the vessel wall does not appear the crack, the leakage phenomenon. fluorine system: the frequency is at least 10 times per minute, the pressure is between 1.1 Mpa——5 Mpa alternately to carry on 60000 times to the fluorine road system impact, the vessel wall does not appear the crack, the leakage phenomenon.	No cracking, leakage	Qualified	Figure 4

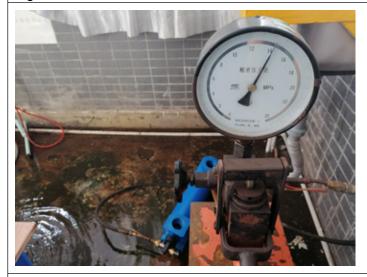
Figure 5: Pressure test

7	Pressure Test	The 6.6 MPa hydraulic test of the fluorine road system is carried out. There should be no leakage and deformation everywhere in the casing fluorine road system, continue to press to 13.2 Mpa, keep pressure 10 min, then drop to 4.4 and keep pressure 10 to observe the welding joints without leakage and allowable deformation.	No cracking, leakage	Qualified	Figure 5				
8		titanium tubes of the same batch of products were taken and placed in a salt spray box for salt spray test. after 480 hours of test, there should be no metal corrosion, falling, peeling, peeling, bubbling (test liquid solubility is 5%).	No corrosion, rust	Qualified	Figure 6				
9	RoHS	All components must comply with RoHS certification requirements.	Vendor reports	Qualified
